Innovative and scientific approaches in water resources management

Igor Ružić PhD

University of Rijeka, Faculty of Civil Engineering (UNIRIFCE)

- SfM photogrammetry - Monitoring of morphological changes of the river Korana by SfM photogrammetry
- 3D monitoring and analysis of Bridges in Nin after the flood and damage of the bridges in 2017
- Measurement of groundwater and sea level in the Euphrasian Basilica complex in Poreč
- Coastal Vulnerability Indeks Analysis –the application of 3D technology

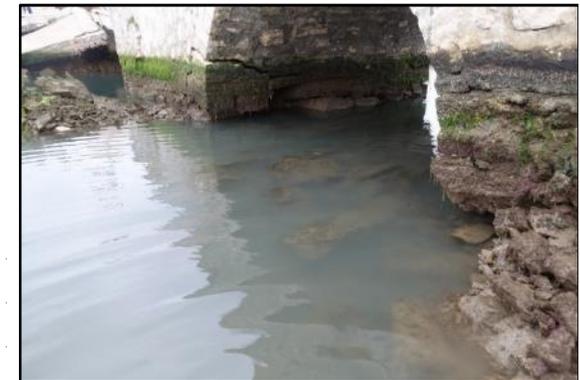
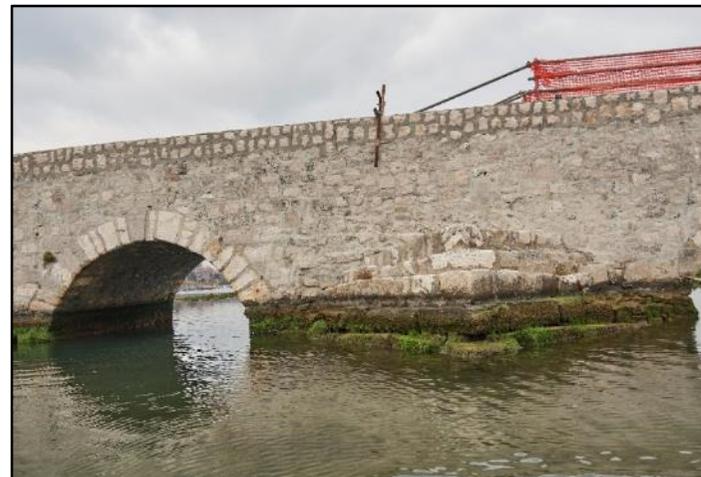
PRESJEK 7-7
STAC: 31.66

City of Nin: 3D monitoring of Upper and Lower City Bridge after the flood damage in 2017

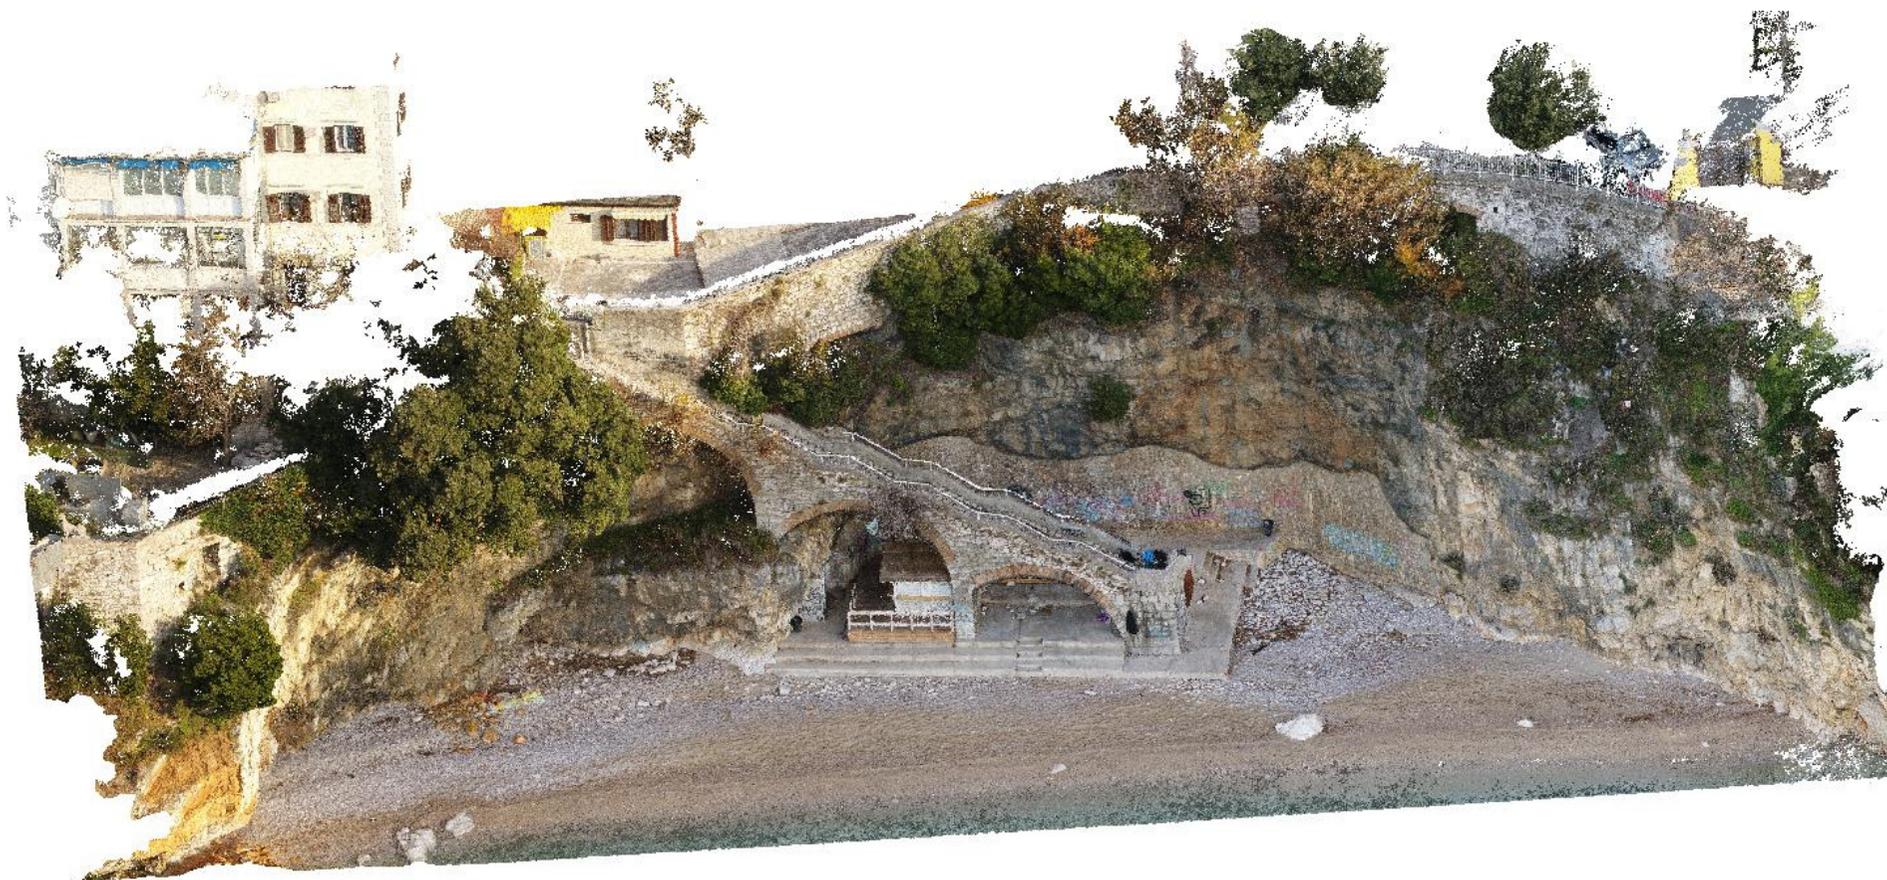
Na plaži Sabličevo (Pećine, Rijeka) dolazi do odrona stjenke mase – opasnost za korisnike plaže
